Manhole Inspection Summary

Manhole # S21I__031MH

Insp Date: **4/7/09 1:50 PM**

Location Address: **121 MONROE ST**

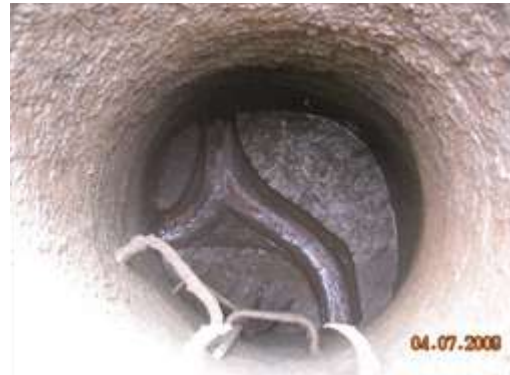
Top View

Offset: **3.5** (in.)

☒ **Leaks**

FRAME OFFSET, EVIDENCE OF INFILTRATION DUE TO SHEETING FROM ROADWAY - FRAME LEAKS

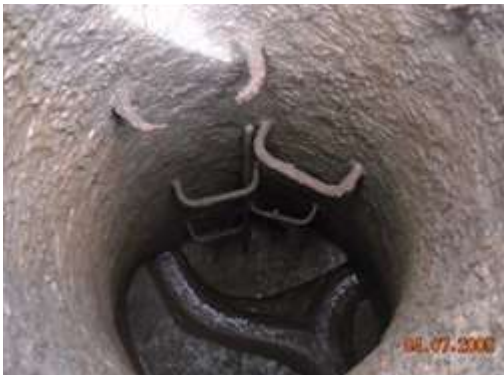
Defect 2

Count: **4** Missing: **2** ☒ **Corroded**

CORRODED/MISSING STEPS

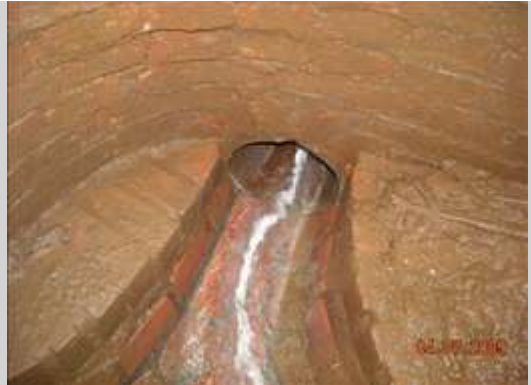
12 O'Clock Outflow

8 in. Circular Gravity Sewer
Pipe Out @ 12 O'Clock

Pipe Height: **8.4** (in.) Rod and Bar (Angled)
Pipe Material: **Clay** ☐ Pipe Lined
Invert Depth: **10.35** (ft.) Flow Characteristics: **Slow**
Deposits: ☒ None ☐ Mud ☐ Sludge ☐ Debris ☐ Grease
Silt Depth: (in.) Deposits Extent:
Infiltration: **None** Pipe Seal Cond: **Sound**

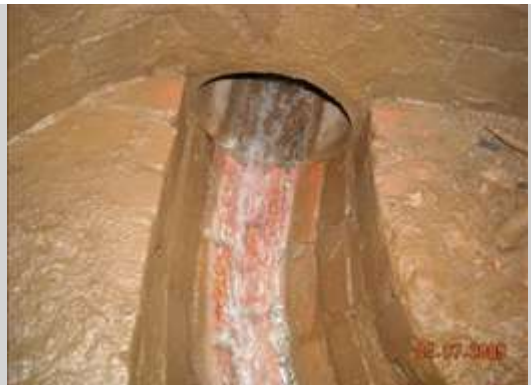
6 O'Clock Inflow

8 in. Circular Gravity Sewer
Pipe In @ 6 O'Clock

Pipe Height: **8.4** (in.) Rod and Bar (Angled)
Pipe Material: **Clay** ☐ Pipe Lined
Invert Depth: **10.00** (ft.) Flow Characteristics: **Slow**
Deposits: ☒ None ☐ Mud ☐ Sludge ☐ Debris ☐ Grease
Silt Depth: (in.) Deposits Extent:
Infiltration: **None** Pipe Seal Cond: **Sound**

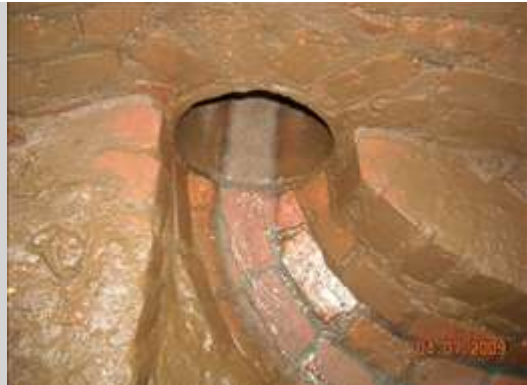
9 O'Clock Inflow

8 in. Circular Gravity Sewer

Pipe In @ 9 O'Clock

Infiltration: **None** Pipe Seal Cond: **Sound**
